## Study of the effect on manufacturing parameters on the fatigue behavior of aluminum engine mounting bracket

Hossein Khalajzadeh<sup>1</sup>, Seyed Vahid Hosseini<sup>\*1</sup>, Alireza Shaterzadeh<sup>1</sup>

<sup>1</sup>Faculty of Mechanical Engineering, Shahrood University of Technology, Shahrood, Iran.

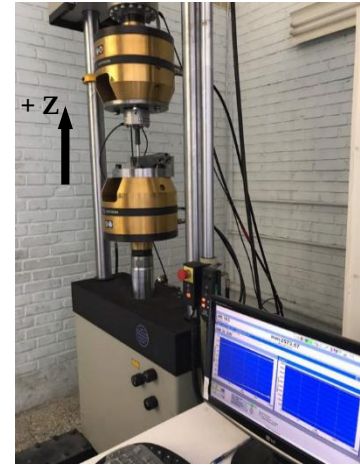
**Figure 1.** Fatigue test with Instron machine in Z direction.

Since the engine mounting bracket plays an essential role in the car, it must be designed and built in such a way that it has high fatigue resistance. In order to assess the fatigue life of the engine mounting bracket, it is imperative to conduct fatigue tests along the Z axis direction [22]. The initial measure, with the purpose of positioning the engine mounting bracket appropriately with repeatability and securing the engine mounting bracket throughout the test, is required. Therefore, the fixture was designed according to the geometry of the part and the requirements of the test. VCN 150 was used to make the main body of the fixture to perform the test in the Z direction due to its good strength, rust resistance and initial hardness of about 35 Rockwell C. The dimensions of the fixture are designed and built according to the dimensions of the device and the work piece. Subsequently, the fatigue test was conducted on the engine mounting bracket employing an Instron 8802 hydraulic servo machine proudly manufactured in England, possessing a remarkable capacity of 250 kN. The dynamometer sensor used is 25 kN manufactured by Instron, which is shown in Figure 1.
