Study of the effect on manufacturing parameters on the fatigue behavior of aluminum engine mounting bracket

Hossein Khalajzadeh¹, Seyed Vahid Hosseini^{*1}, Alireza Shaterzadeh¹

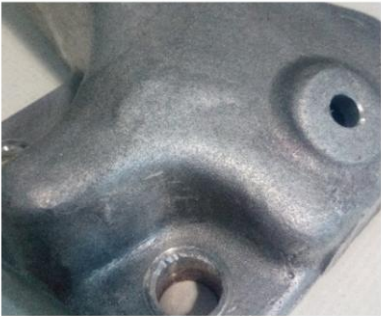
The reinforcement of the connection area of the base to the wall in the modified sample has led to the removal of the crack in this area. In order to make a more detailed investigation, after the completion of the fatigue test, a comparison of the primary and secondary samples was made by conducting a penetrating liquid test. Also, after fixing the manufacturing parameters to cause the cracks in the part, by repeating the high-cycle fatigue test on the modified sample, the crack moved from the connection area of the base to the wall to the end area of the part, as shown in Figure 11. This means that similar to the finite element results in the modified sample, the most critical region is located at point A. Table 9 shows the improvement of the modified sample respected to primary sample. As observed, the resistance of modified sample increased by 7% and scatter of fatigue results has decreased by 14%.

Figure 11. a) Identification of the crack in the front area of the primary sample. b) Removal of the crack in the front area of the modified sample. c) Appearance of a crack in the end area of the modified sample.
