Technical Note

AN EXPERIMENTAL AND THEORETICAL INVESTIGATION OF CORROSION MECHANISM IN A METALLIC STACK

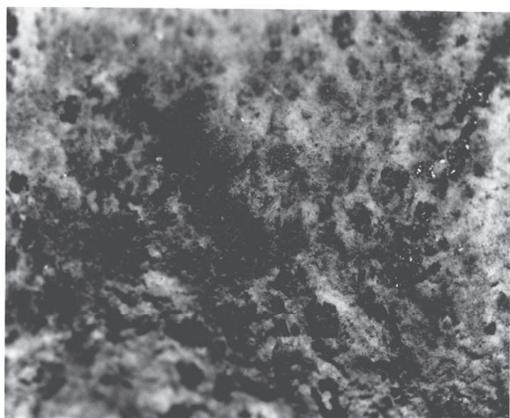
The sediments in the interior surface of stack are shown in figures 4 and 5. In this section, the sediments are cracked and there is no effect of sediment white crystals. Orange and black corroded sections are observed clearly.

Fig. 5. The stereo image of the interior surface of stack (x 259)

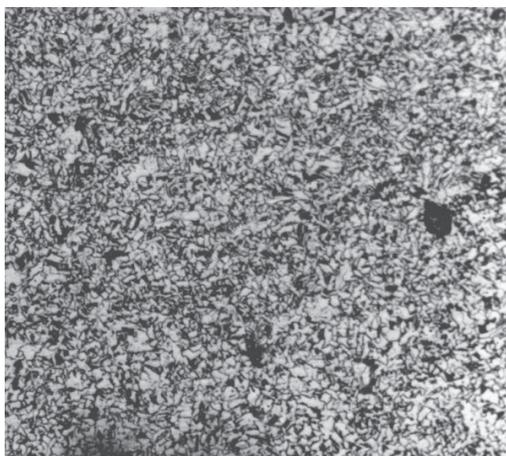
After cleaning, polishing and mounting, samples were etched by the 2% Nital solution. Nital is a solution of alcohol and nitric acid commonly used for routine etching of metals. It is especially suitable for revealing the microstructure of carbon steels. The microscopic structure of the stack plate is shown in figure 6. Structure of samples is ferrite-perlite and perlite areas are focused in the grain boundary. Therefore, structure of low carbon steels is observed.

Fig. 6. Microscopic structure of stack plate 2% Nital (x 33)

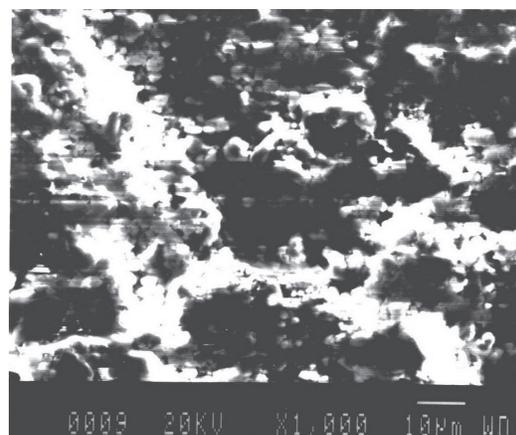
capable of magnifications up to 20,000X. SEMs were taken and observed in order to support our findings. Samples of each sample to a square centimeter dimensions obtained by electron microscopy and their surface without applying coating was investigated. SEM images on the flue surface are shown at figure 7 and 8. The pitting and corroded white sediments areas are seen clearly.

Fig 8. SEM microscope image surface of stack (in higher magnification)
